Ottawa Street Station Transformation

Accident Fund Insurance Headquarters

Building Enclosure Council Presentation

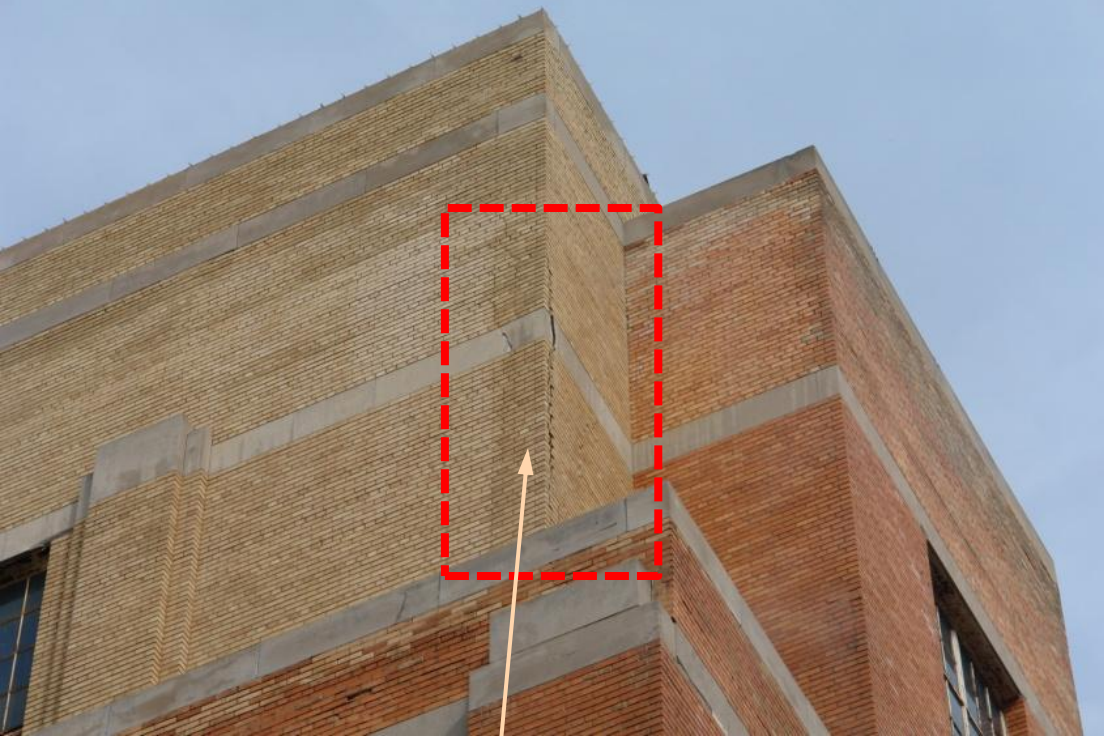
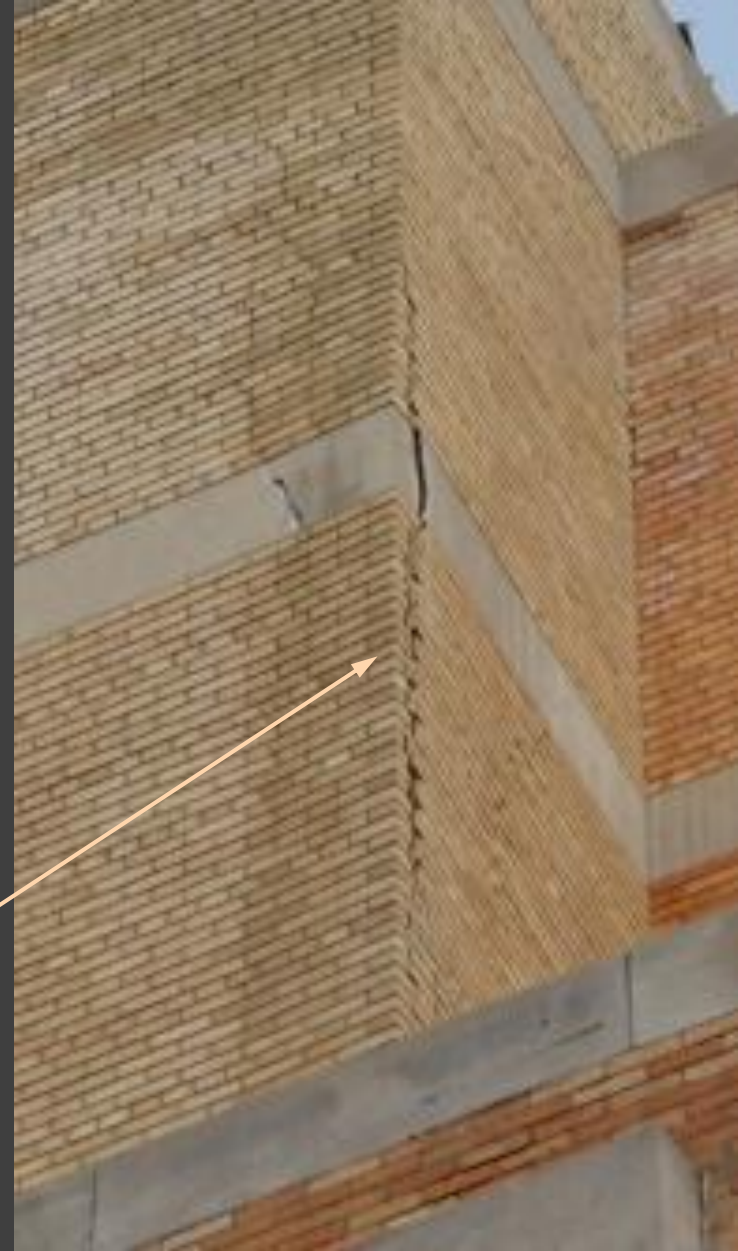
Crack in Masonry & Mortar
Joint with Pivoting
Displacement 2"+ Out of Plane

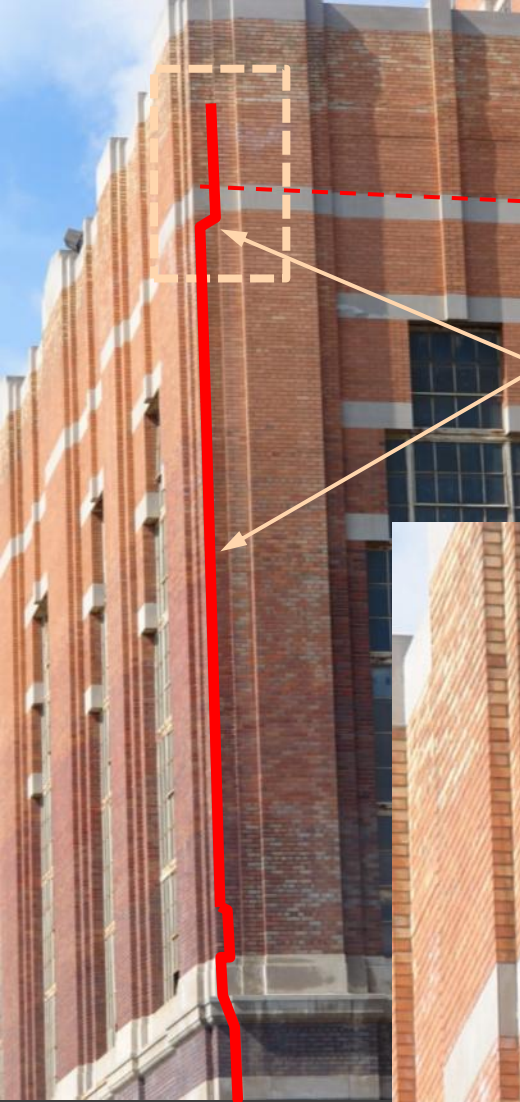
West Elevation

Crack in Masonry & Mortar
Joint with Displacement
Out of Plane

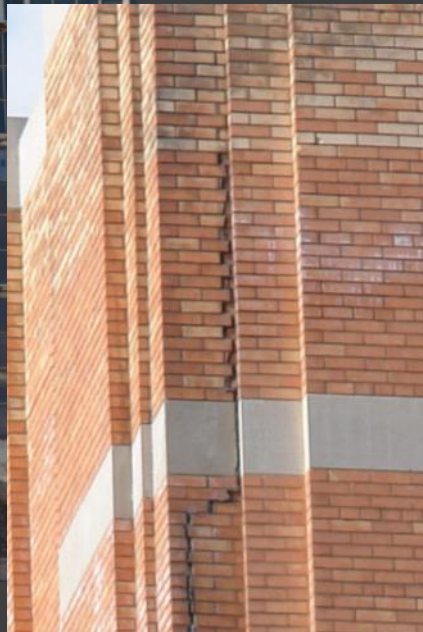
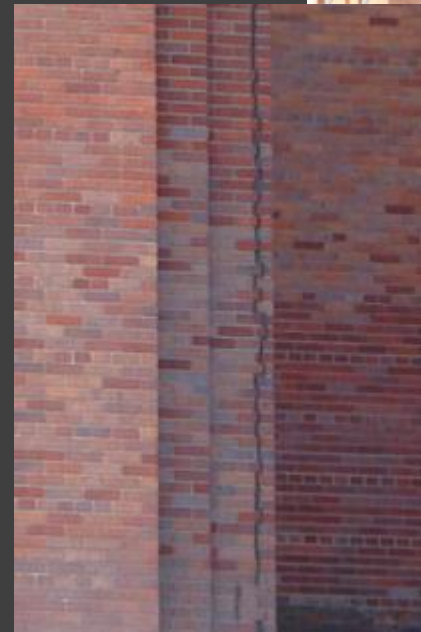
Crack in Masonry &
Mortar Joint

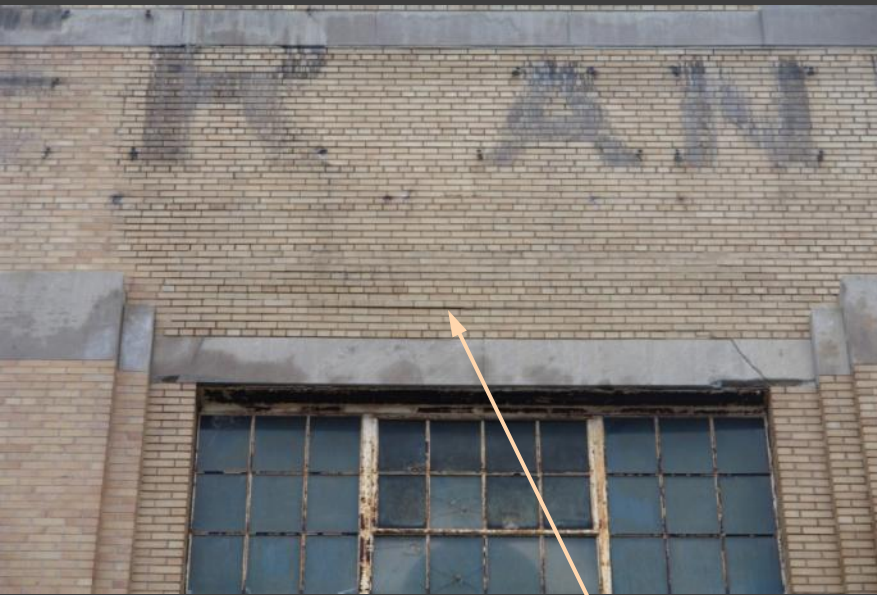
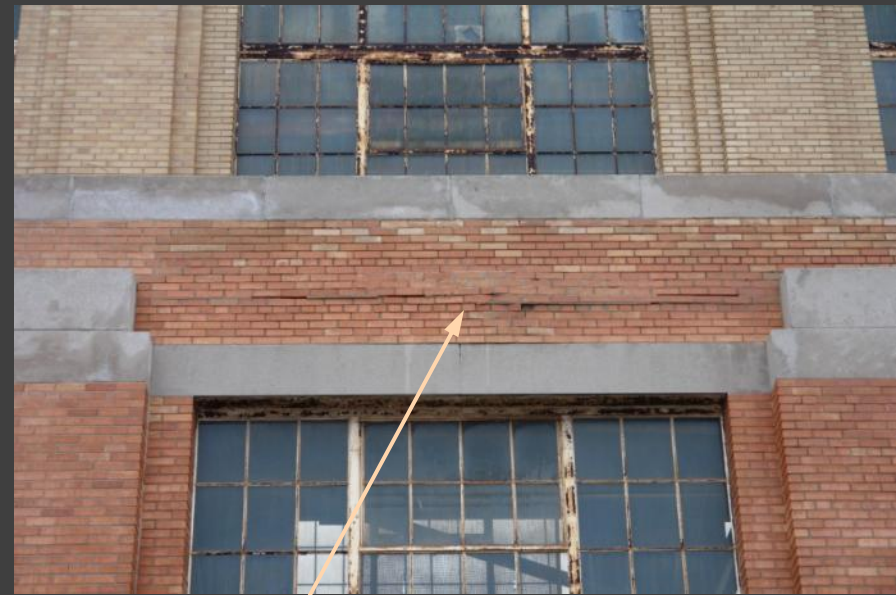
East Elevation

Crack and Displacement Out of Plane in the Masonry

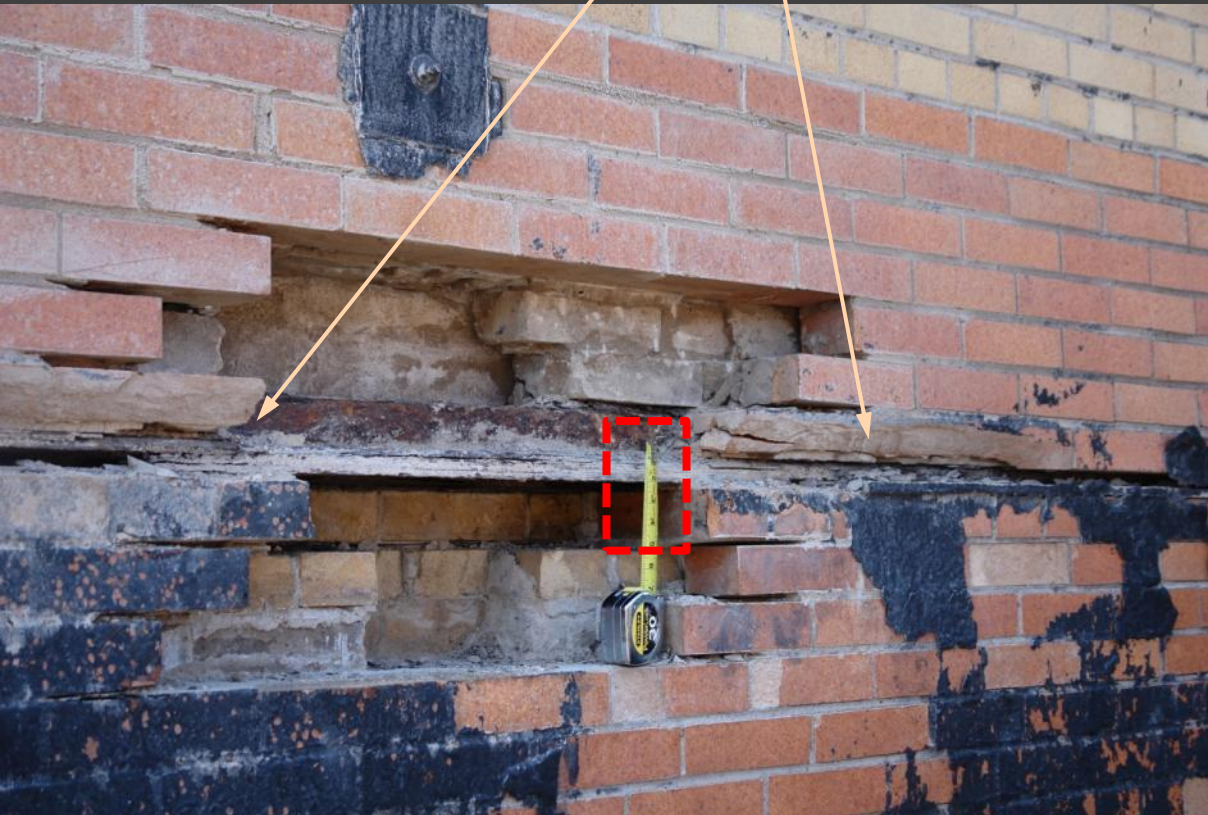
4"x16"x56" Limestone Section
Dislodged from the Masonry

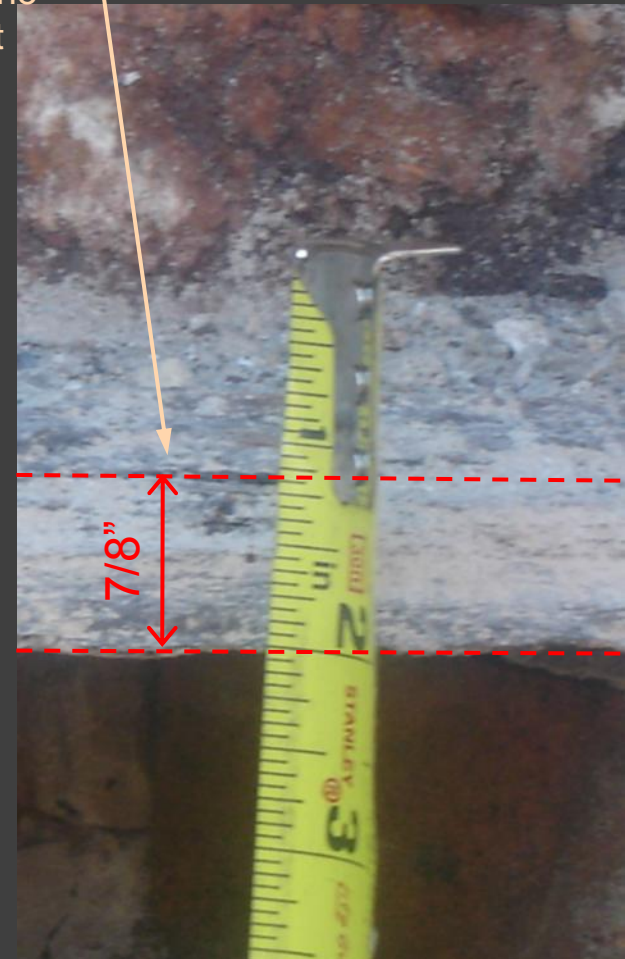
Sever Delamination of Steel
Angles Supporting Limestone
& Laterally Bracing Parapet

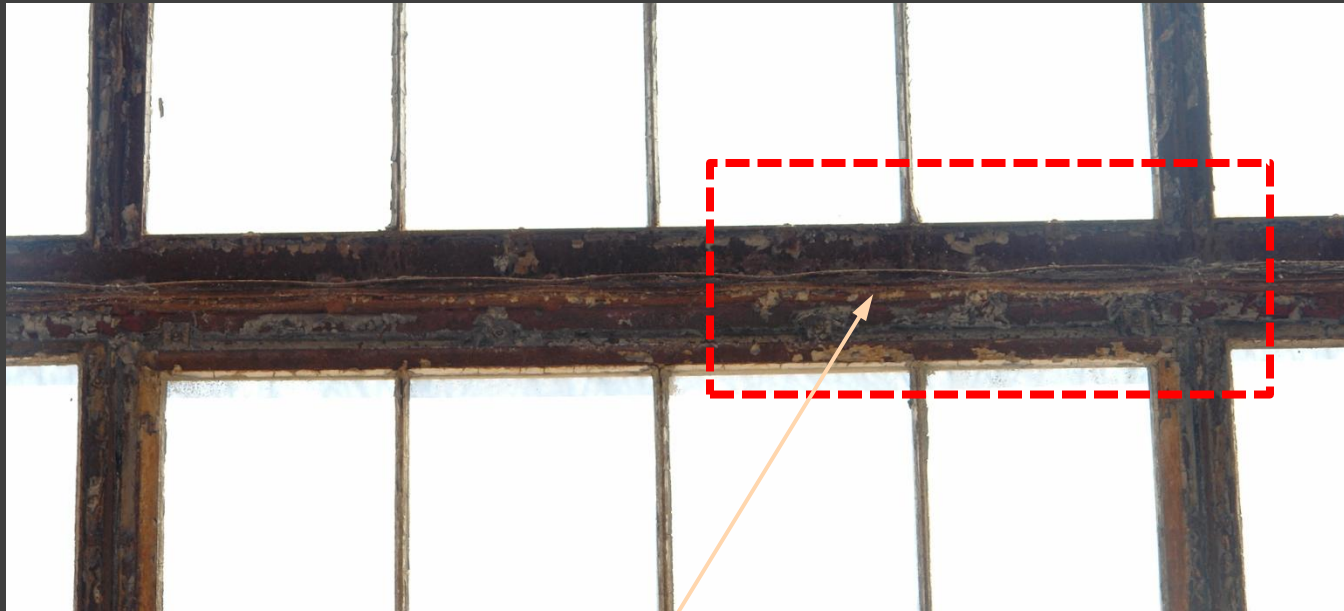
Rust jacking of steel
window angles

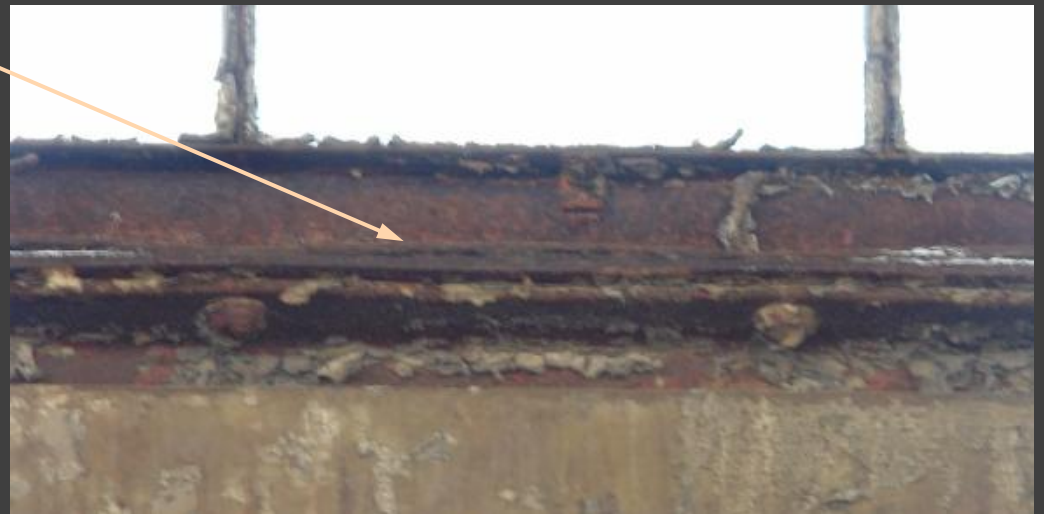
Rust jacking of steel
window angles

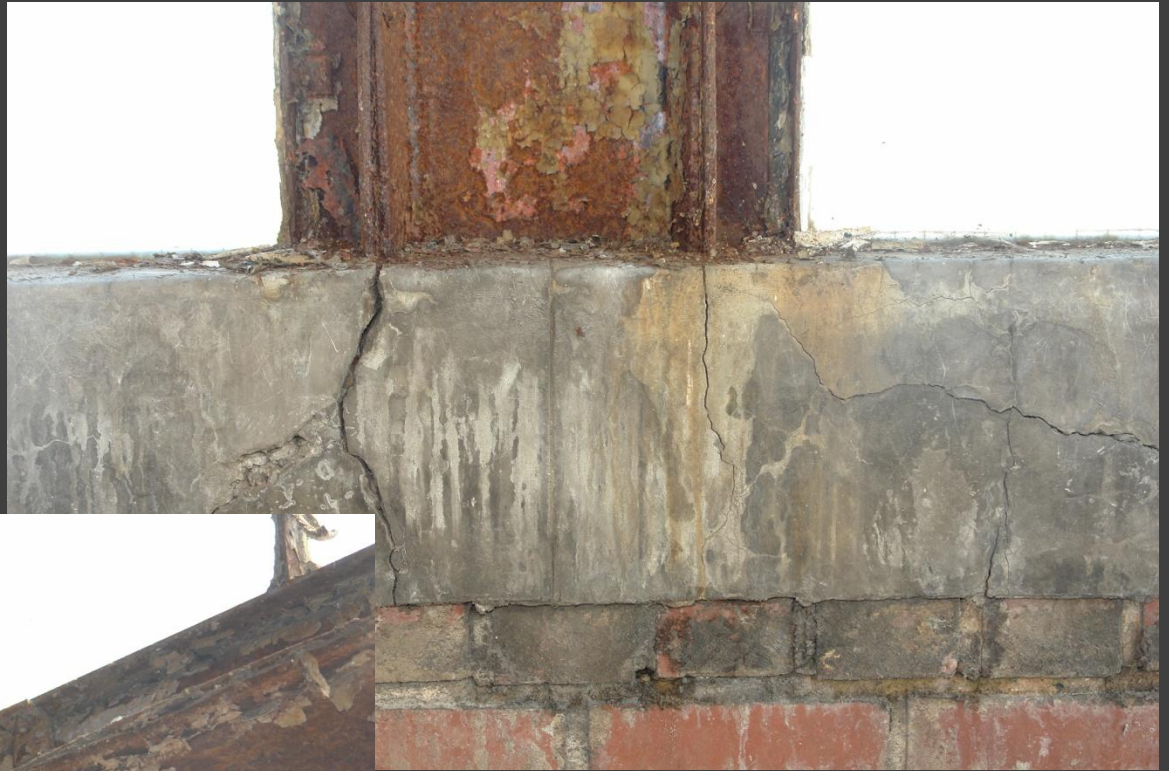
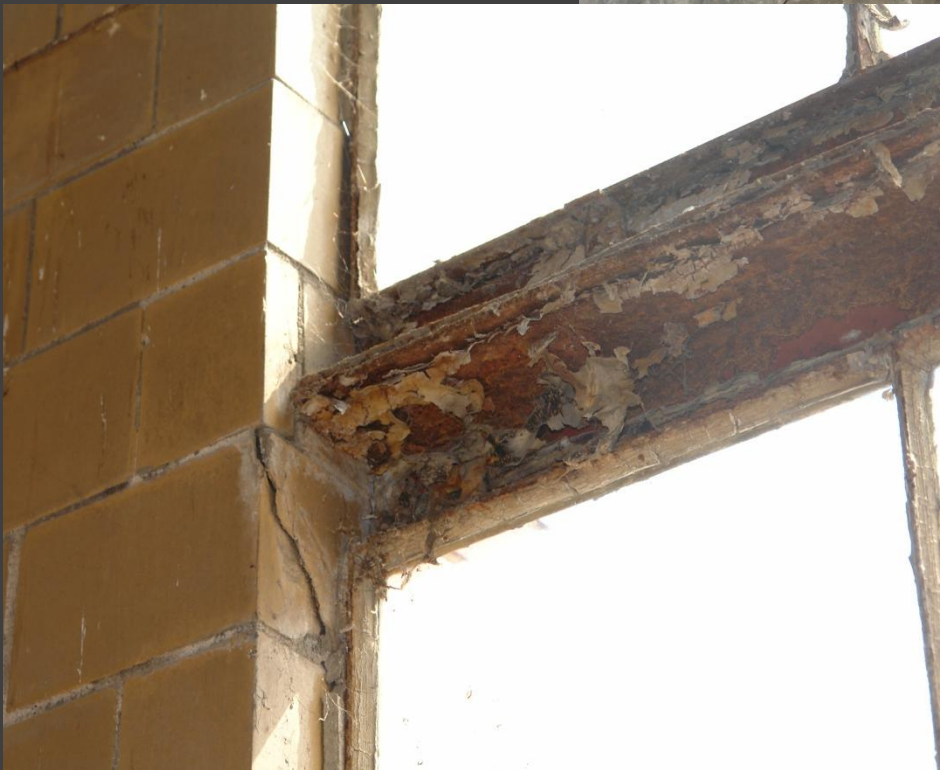
Damage at masonry jambs and sills due to steel angles rusting
