AIA CES PROGRAM MPS 03

Flashing and its Importance in All Buildings

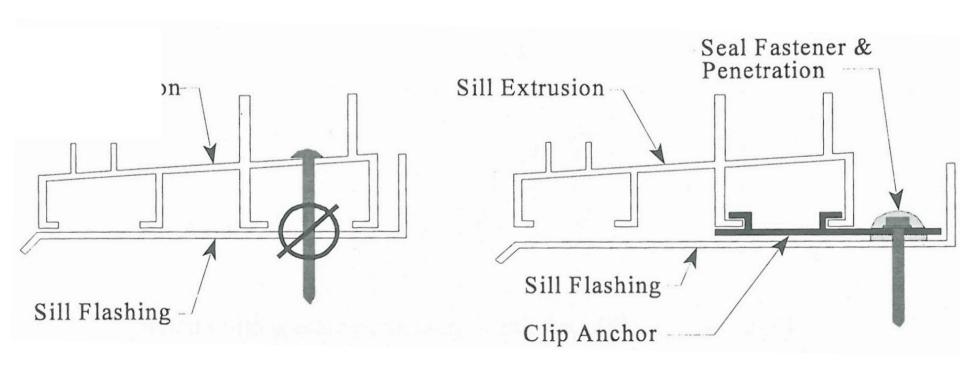
FIGURE 5: Sill Anchorage Considerations to Avoid Blind Penetrations in Sill Flashings

Window Detail Consideration for Leakage Prevention Kenneth M. Lies & Brian A. Faith

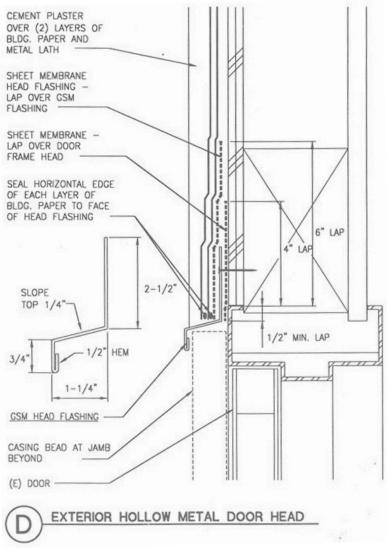
FIGURE 2: Cross-Section Detail at Enlarged Scale with Separation of Materials and Exaggerated Line Thickness

A Detailing Method for Improving Leakage Prevention of Exterior Wall Weatherproofing - Robert Bateman

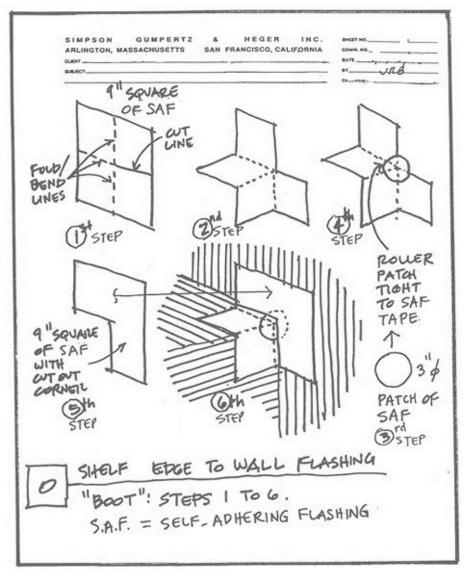
FIGURE 7: Combined 3-D & Sequence Diagrams (Freehand Sketches)

A Detailing Method for Improving Leakage Prevention of Exterior Wall Weatherproofing - Robert Bateman

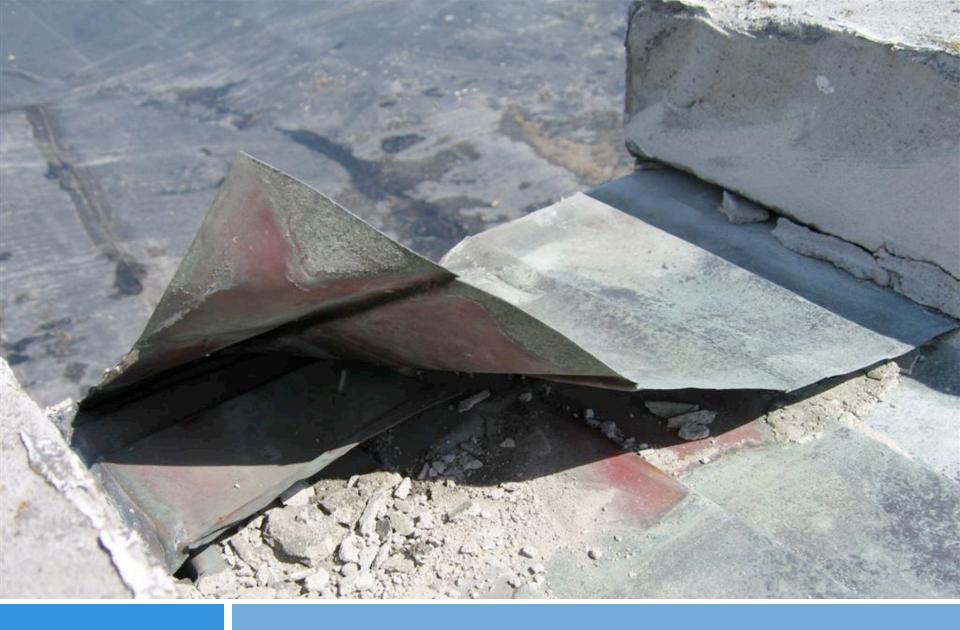
Loose laps

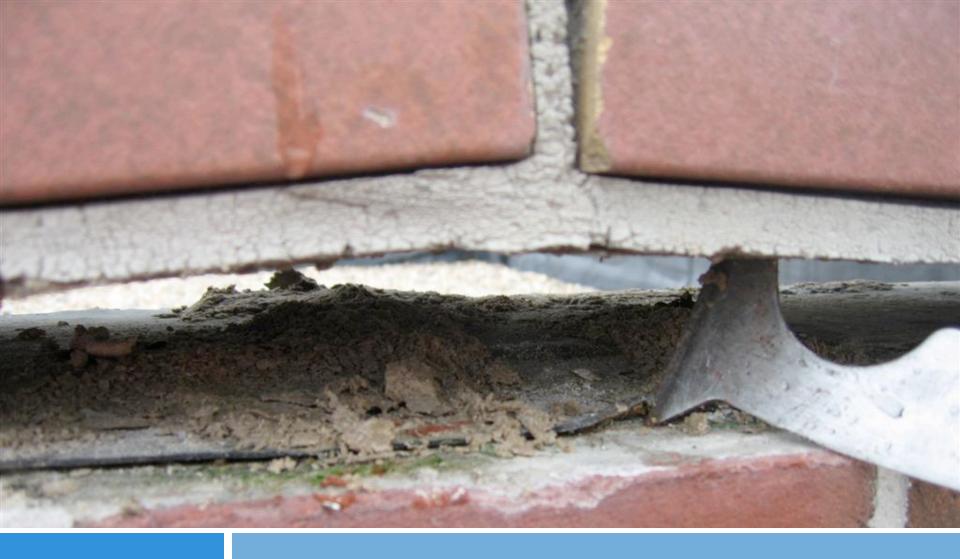
Bond loss & freeze-thaw impact

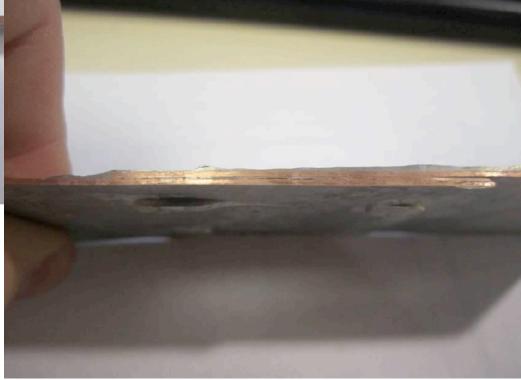
QA/QC - Soldering Test: Fail

3/4 in. lock joint with pinholes, not filled with solder

Lap joint not filled with solder

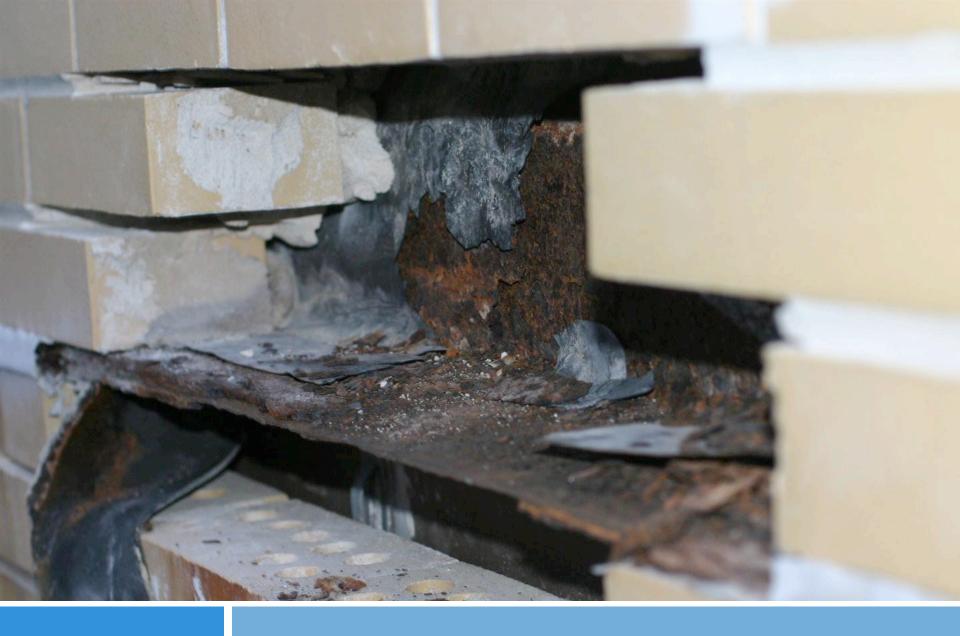
Corrosion by-product

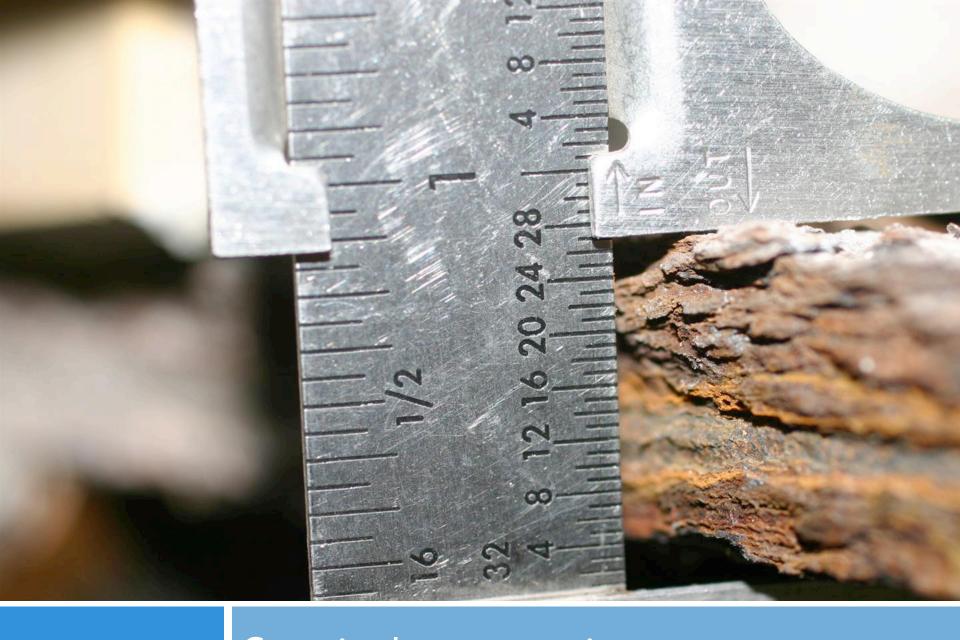
Corrosion layer expansion

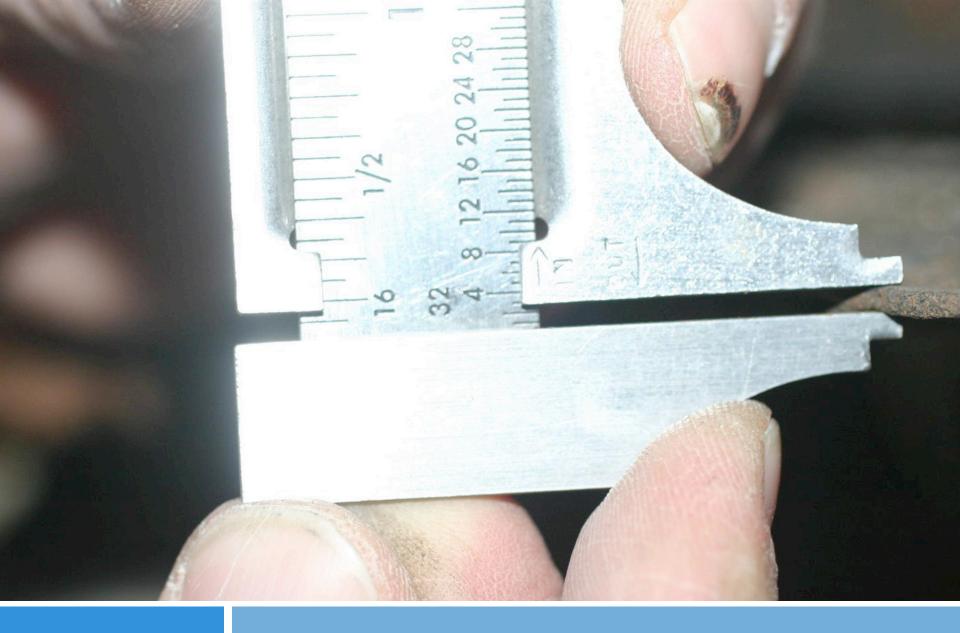
Corrosion layers removed

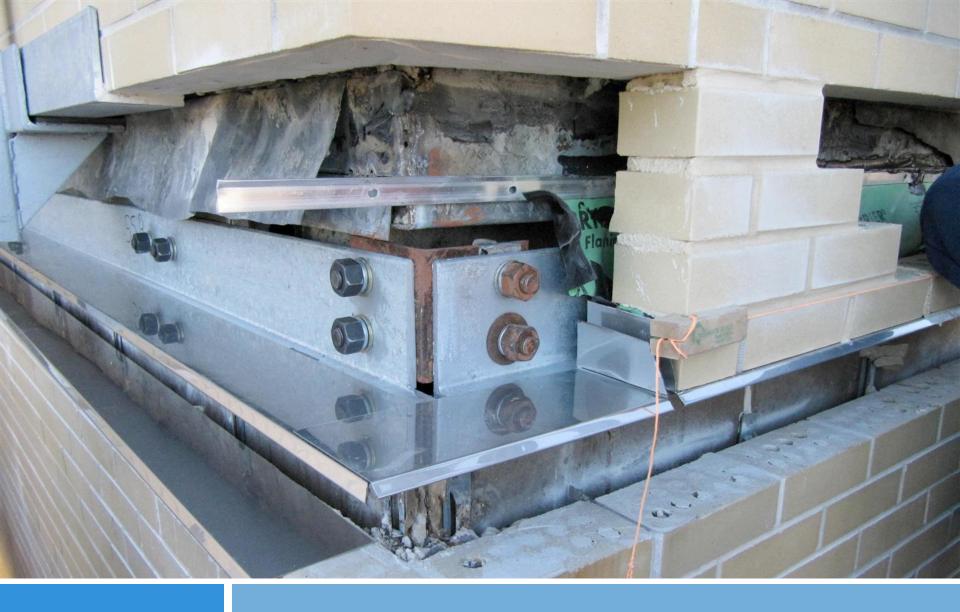
Corner shelf angle replacement and flashing

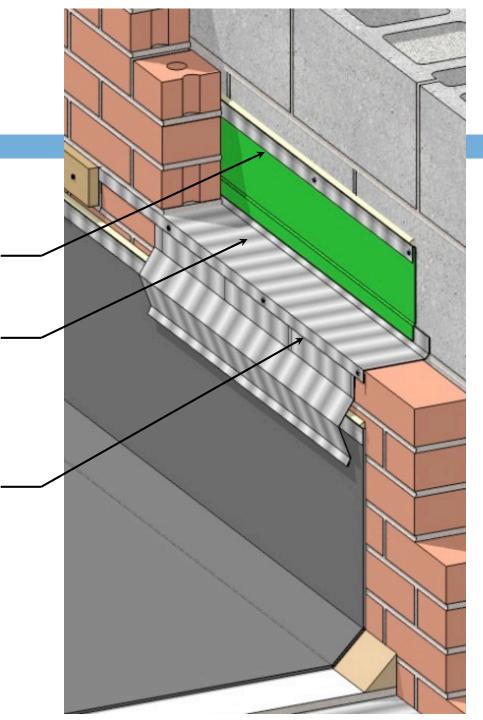
Rising Wall

Positive termination

Through-wall flashing

Counterflashing receiver

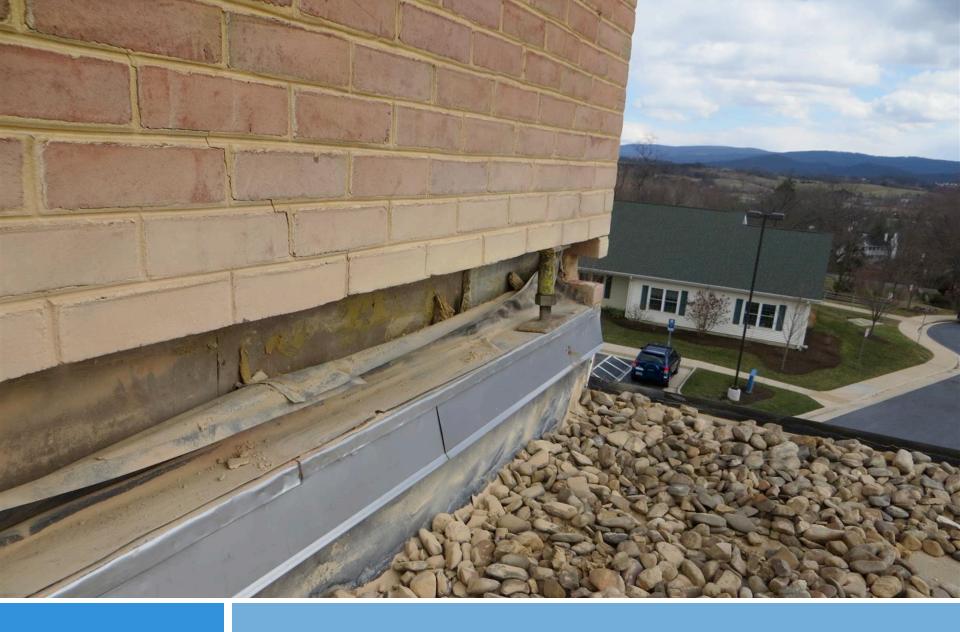
Flashing replacement already completed once

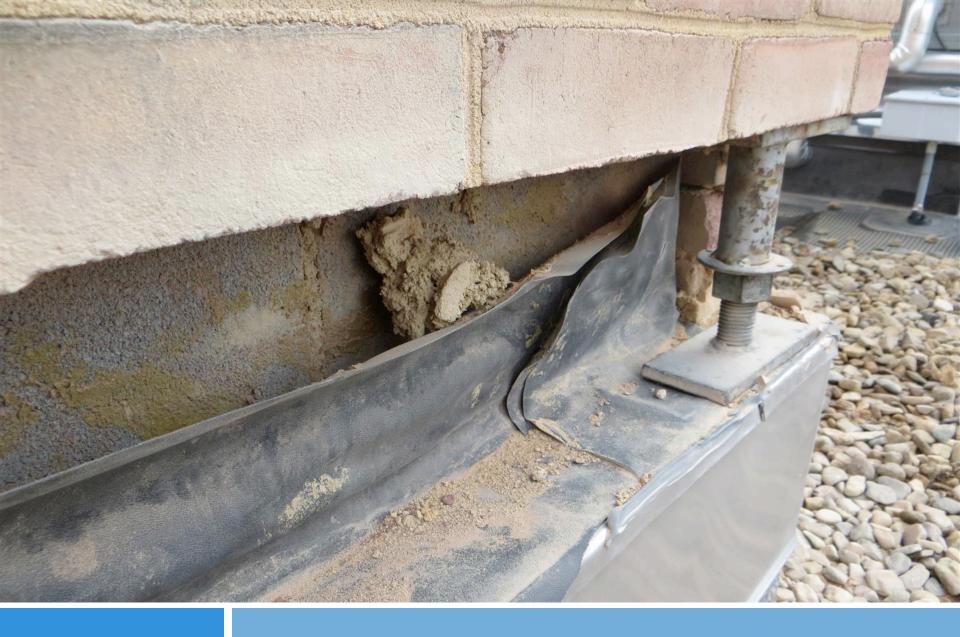
Flashing not properly terminated in the cavity

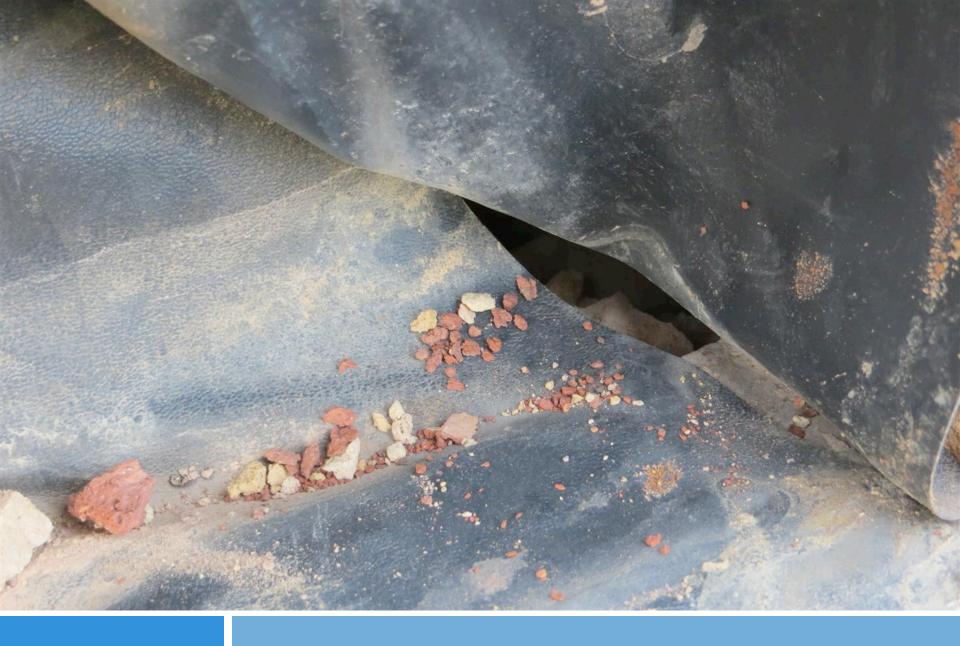
Plastic flashing was not sealed at lap joints

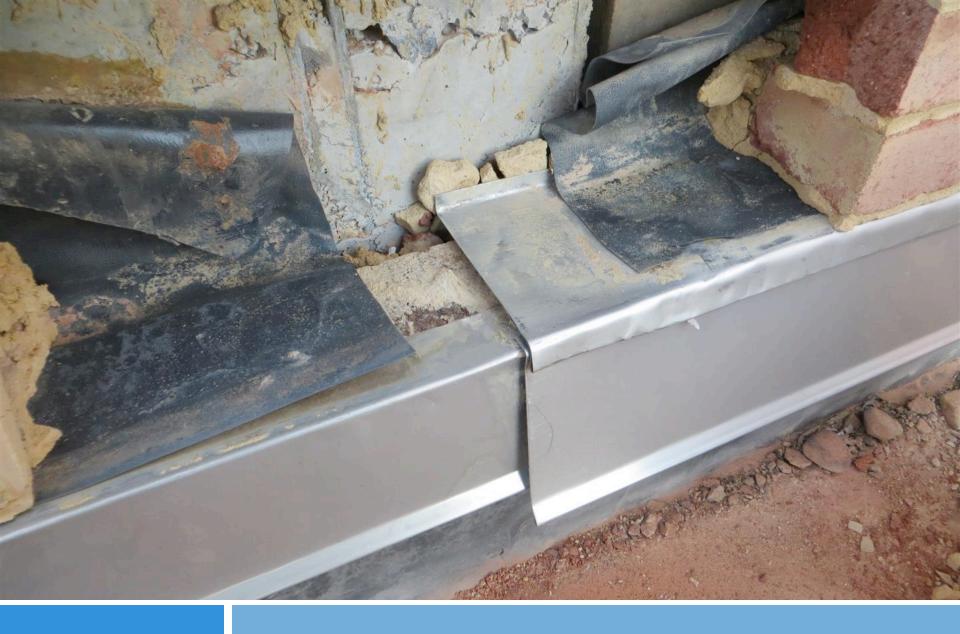
No continuity
