Ottawa Street Station Transformation

Accident Fund Insurance Headquarters

Building Enclosure Council Presentation

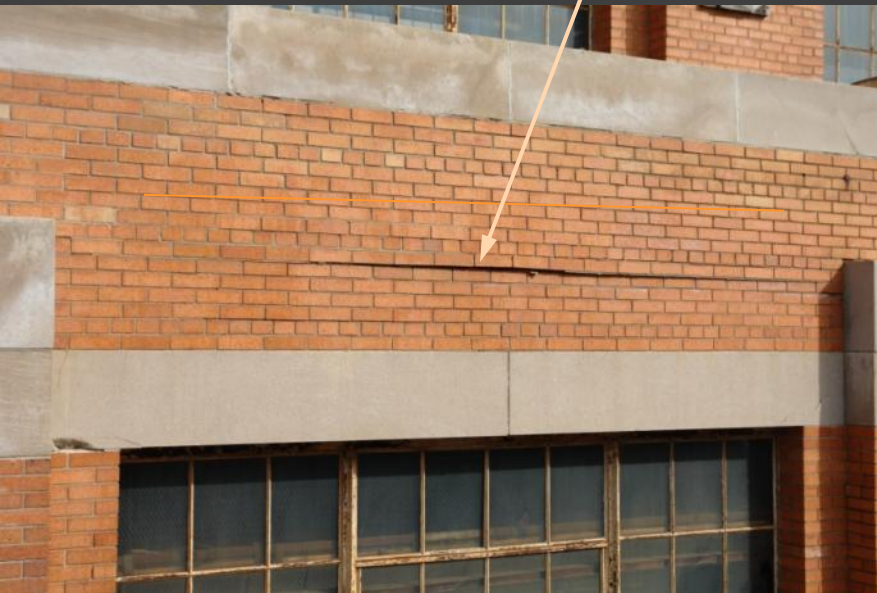
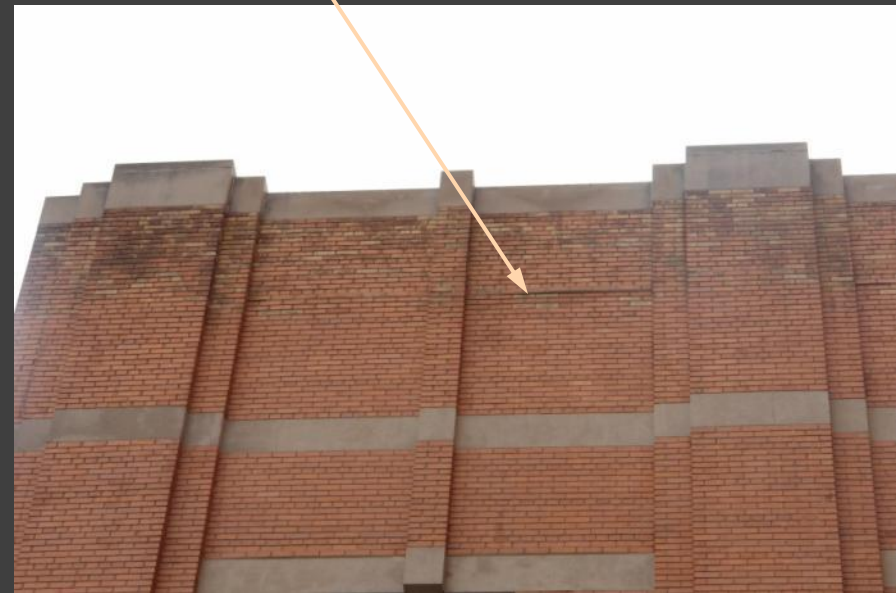
Crack and Displacement Out of Plane in the Masonry

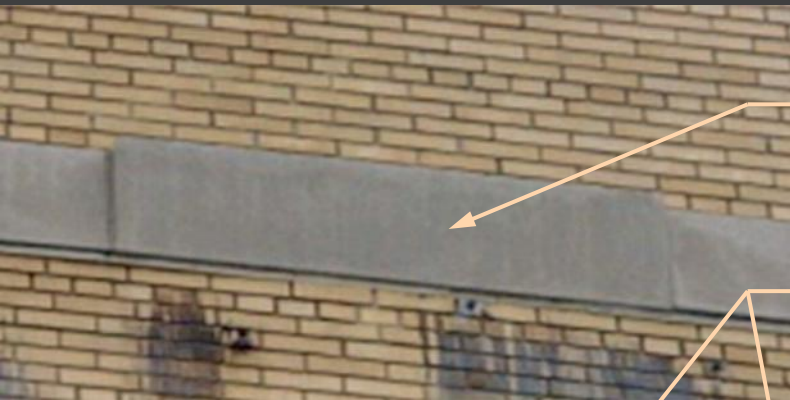
4"x16"x56" Limestone Section
Dislodged from the Masonry

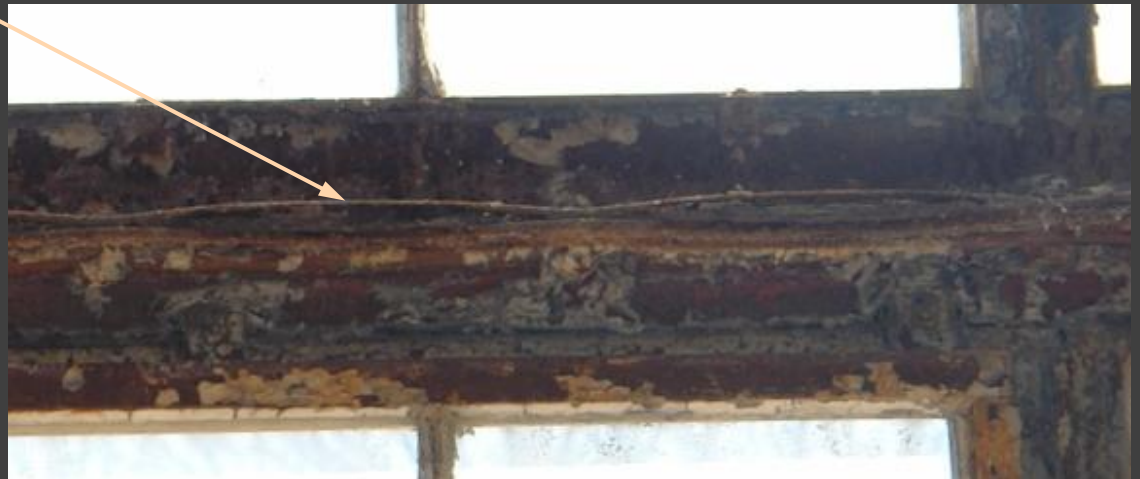
Rust jacking of steel
window angles
